REPORT: FE-19-97

RAILROAD: Norfolk Southern Railway Company (NS)

LOCATION: Rowesville, South Carolina

DATE TIME: June 24, 1997, 8:58 p.m., EST

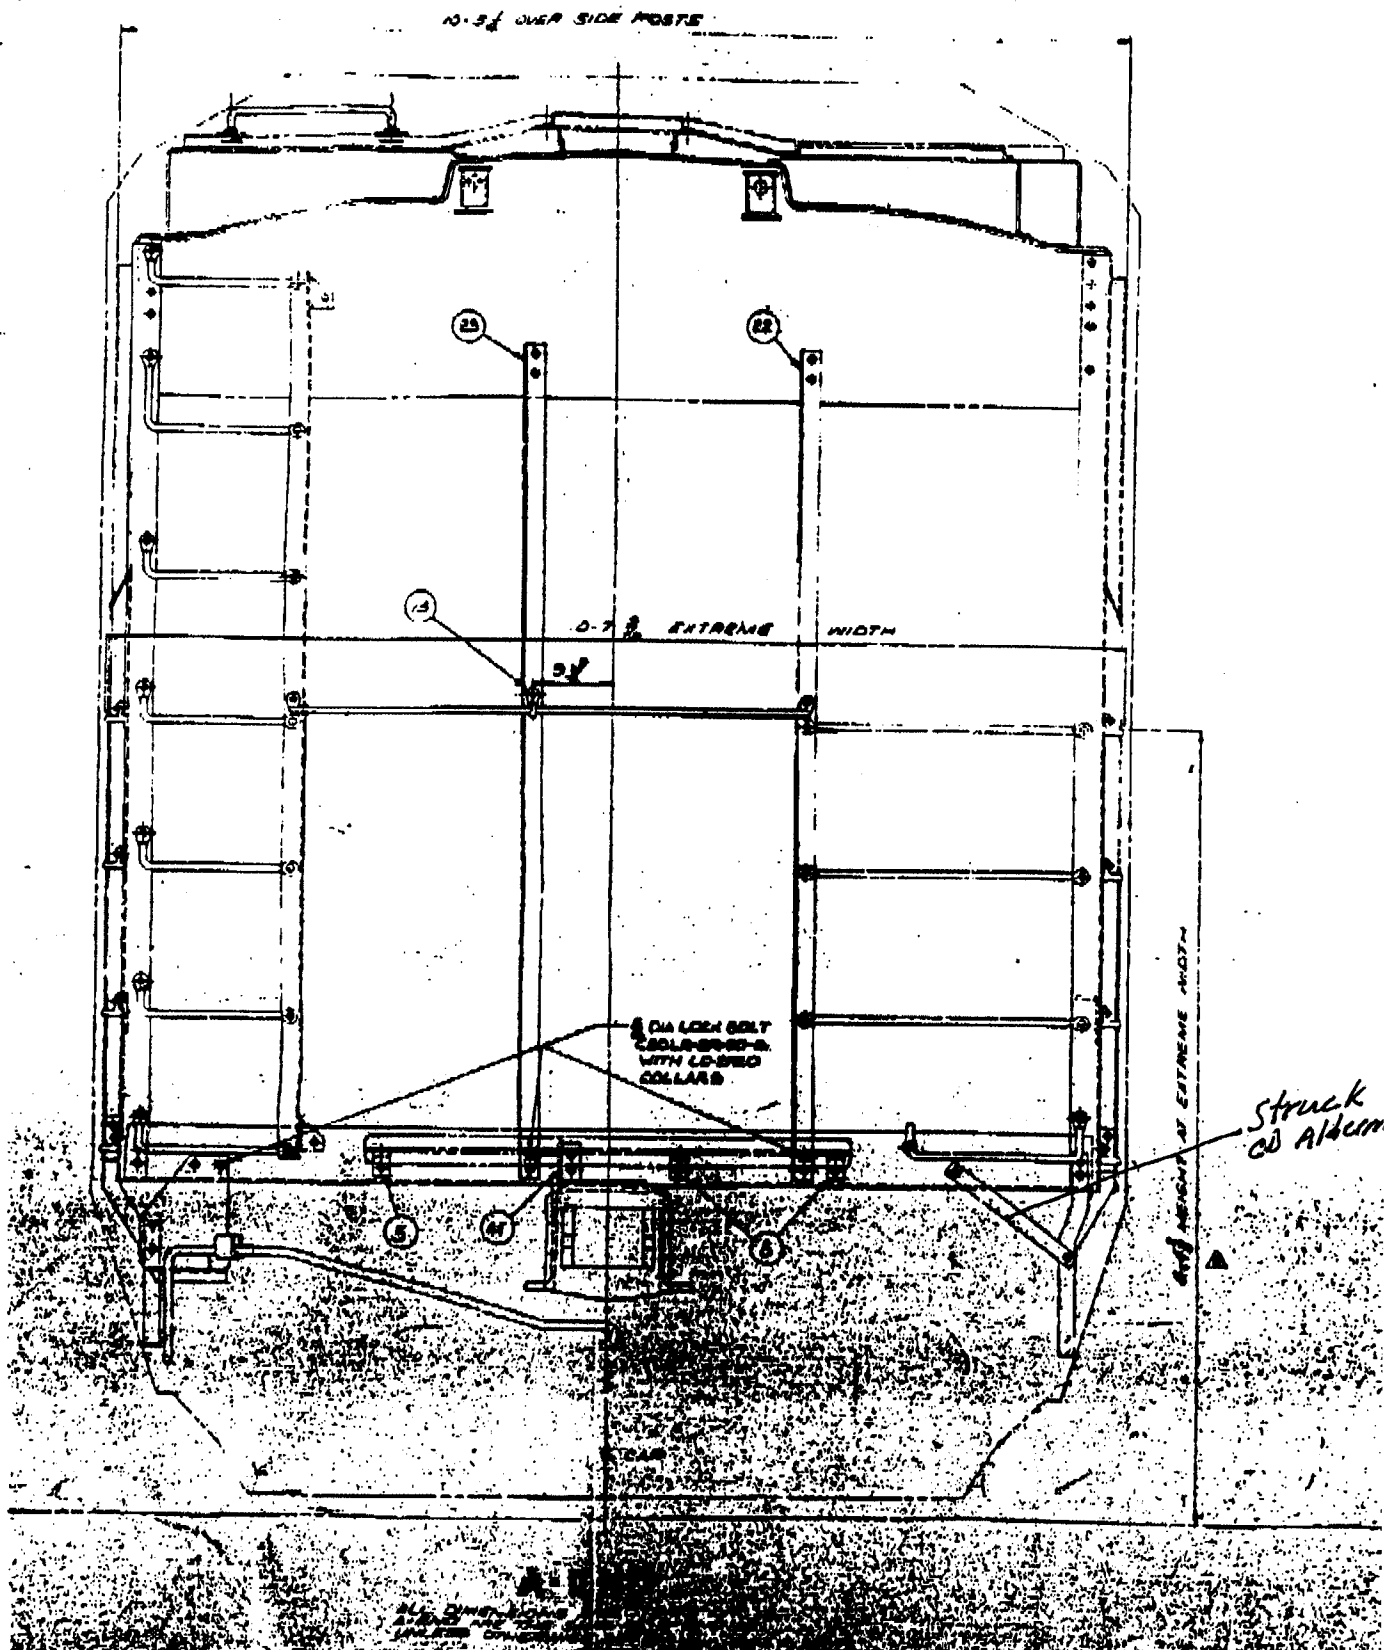
ROWESVILLE, SC

The post-accident investigation disclosed that the Conductor had failed to line the switch for the mainline after applying the EOT to the rear of Rail Car SOU 88568. After pulling west from the siding with five cars and applying the EOT, the Conductor instructed the Engineer to shove east, informing the Engineer that the track was clear for 30 car lengths, but only to shove back five car lengths. The Conductor’s intent was to cut two cars off of the mainline and return to the siding with the three remaining cars.

Evidence indicates that as the shoving move began, the Conductor turned away from the rolling equipment and walked toward the west in the foul of the siding track. At the same time, utilizing his radio, he was issuing movement instructions to the Engineer. The Conductor’s failure to properly line the main track switch resulted in the cars re-entering the siding and
